# **INDOOR AIR QUALITY ASSESSMENT**

**Department of Social Services  
100 North Front Street  
New Bedford, Massachusetts**

Prepared by:  
Massachusetts Department of Public Health  
Bureau of Environmental Health  
Emergency Response/Indoor Air Quality Program  
June 2007

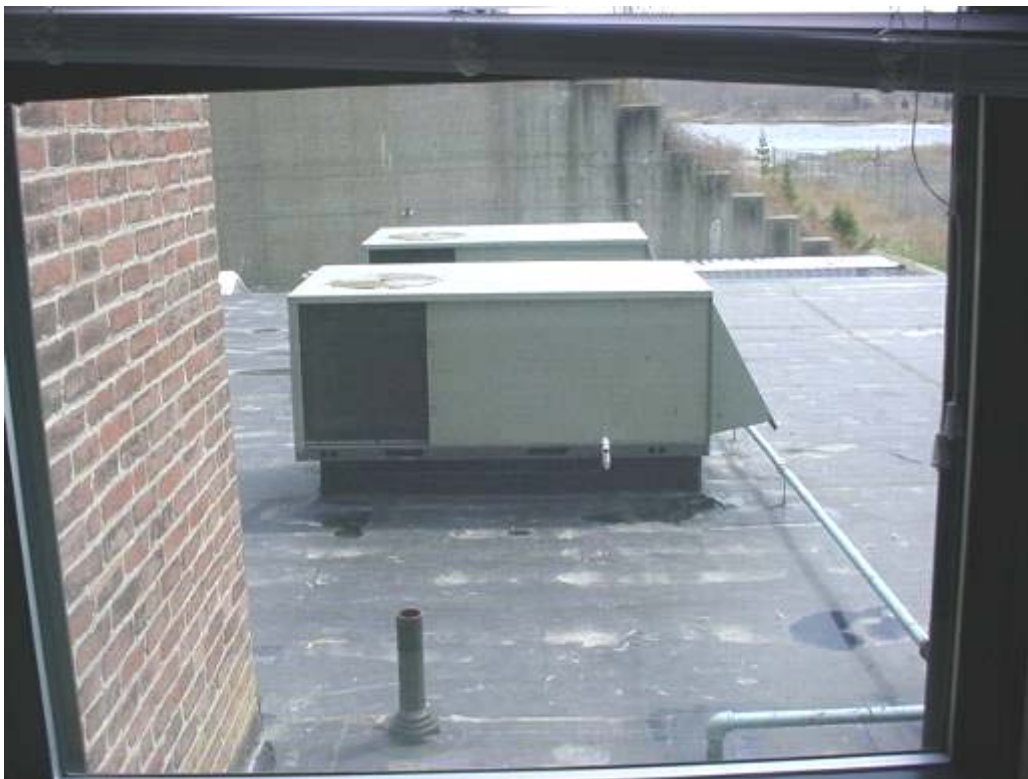
**Picture 1**

It can be seen from Table 1 that carbon dioxide levels were elevated above 800 parts per million (ppm) in forty-three of fifty-three areas surveyed, indicating poor air exchange in the majority of areas surveyed during the assessment. Mechanical ventilation is provided by air-handling units (AHUs) located on the rooftop or on the exterior of the building (Pictures 1 and 2). Fresh air is drawn into the AHUs and delivered to occupied areas via ceiling-mounted air diffusers (Picture 3). Return air is drawn into ceiling-mounted grates (Picture 4) into an above ceiling plenum where it is ducted back to the AHUs.

**Rooftop AHUs**

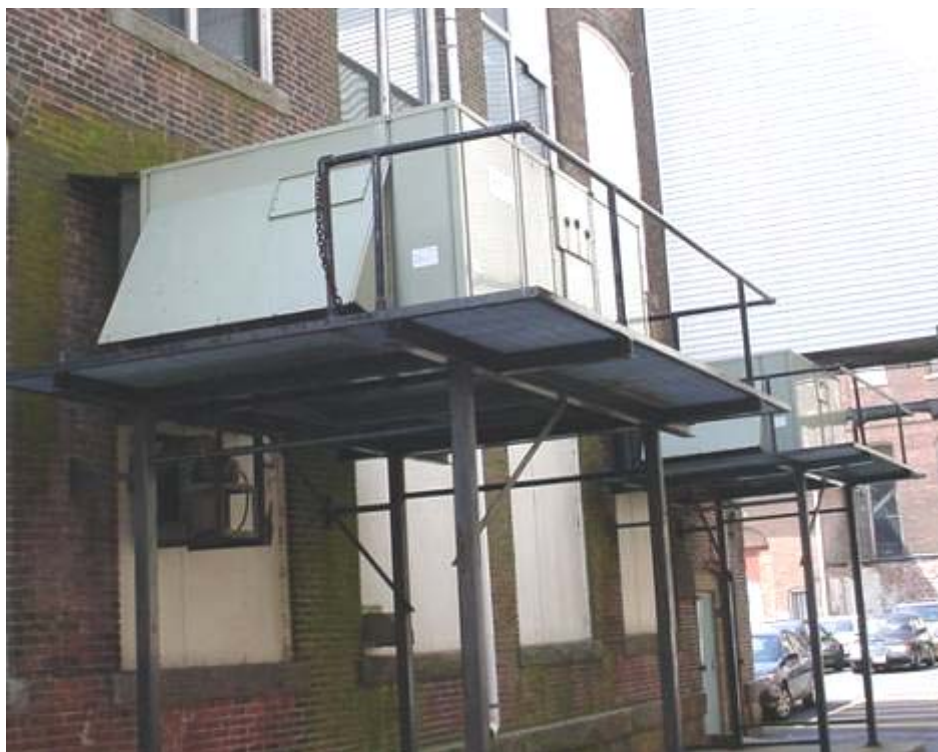
**Picture 2**

**AHUs on Exterior of Building**

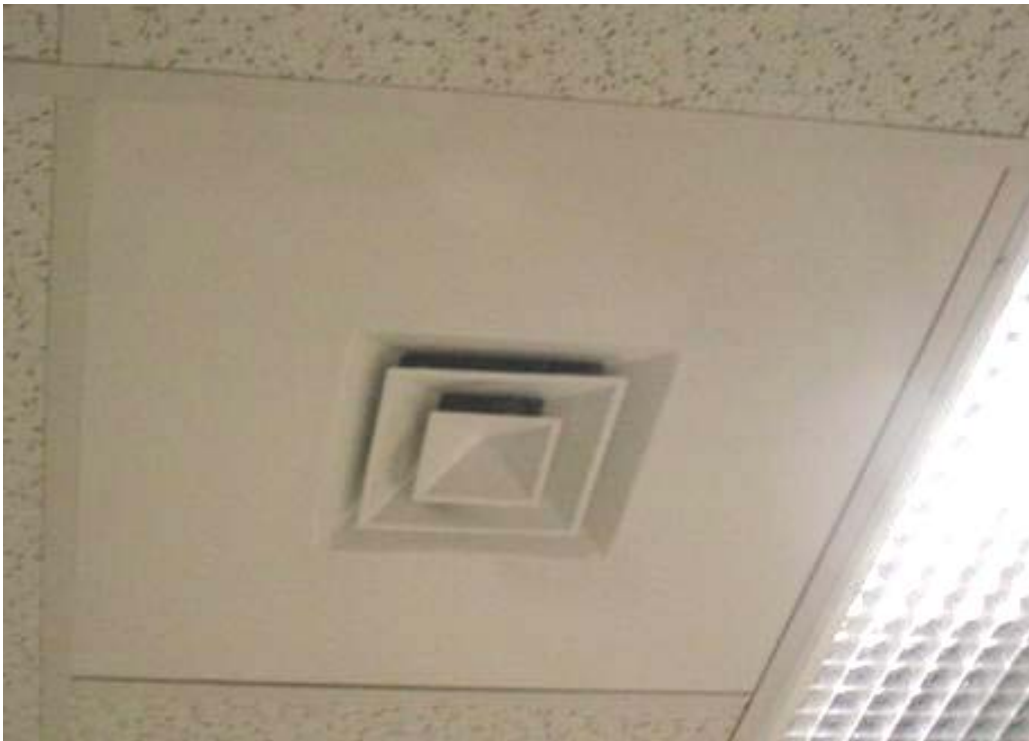
**Picture 3**

**Ceiling-Mounted Air Diffuser**

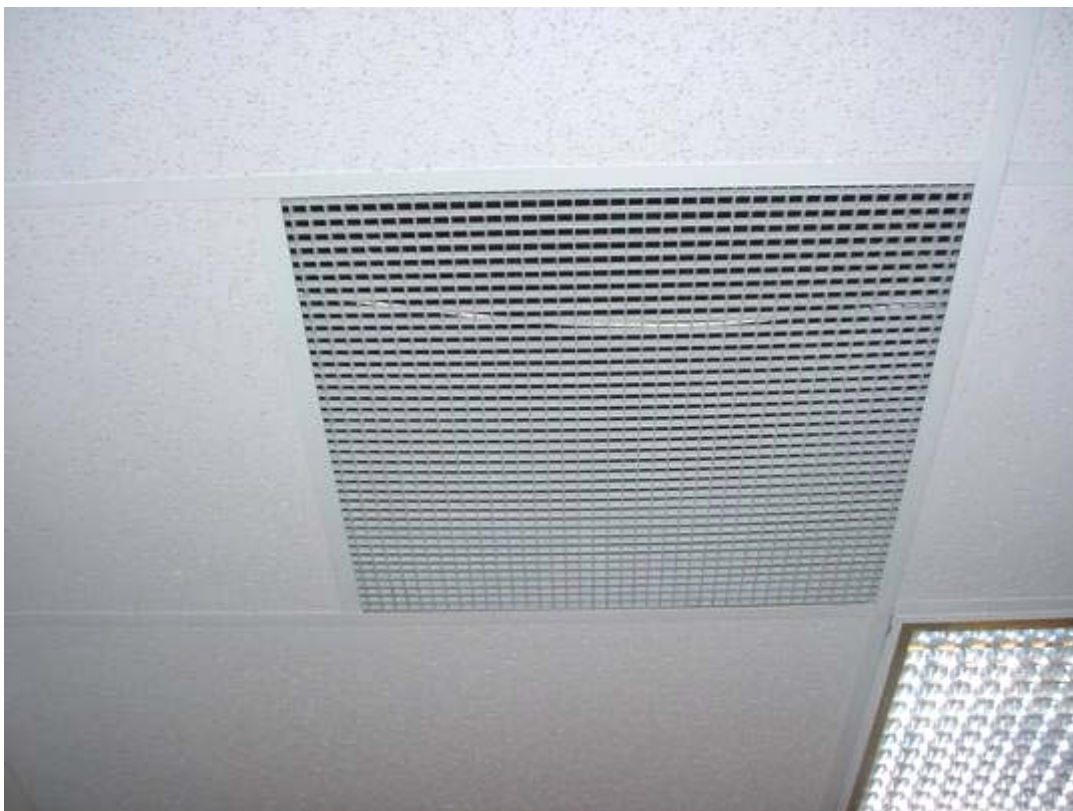
**Picture 4**

**Ceiling-Mounted Return Grate**

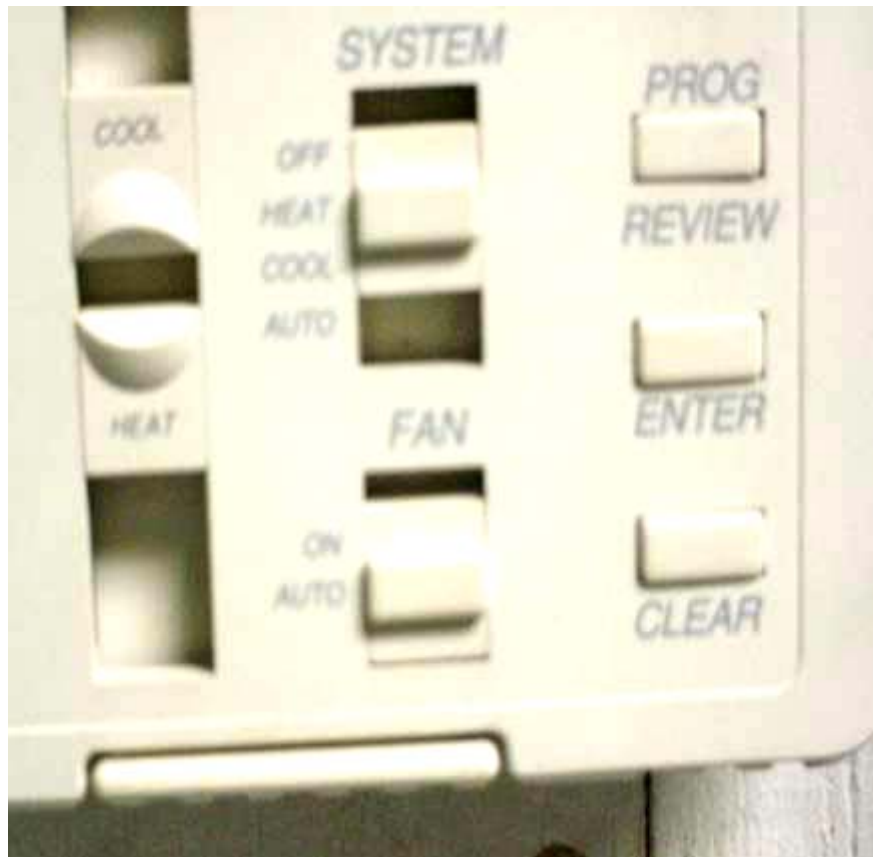
**Picture 5**

Thermostats control each heating, ventilating and air conditioning (HVAC) system. Thermostats have fan settings of “on” and “automatic”. Thermostats had been set to the “automatic” setting in areas surveyed during the assessment (Picture 5). The automatic setting on the thermostat activates the HVAC system at a preset temperature. Once a preset temperature is measured by the thermostat, the HVAC system is deactivated. Therefore no mechanical ventilation is provided until the thermostat re-activates the system. Without dilution and removal by the mechanical ventilation system, commonly occurring indoor air pollutants can build up and lead to indoor air quality/comfort complaints. This was the case in the area of the DSS where the staff member was experiencing discomfort due to chronic dry eye syndrome. To provide air circulation a personal fan was being used in this office, however the movement of air from the fan may create air currents which can further dry out eyes and exacerbate irritation.

**Close-up of Thermostat**

1. Operate ventilation systems in the fan “on” mode to provide continuous air circulation during periods of occupancy.

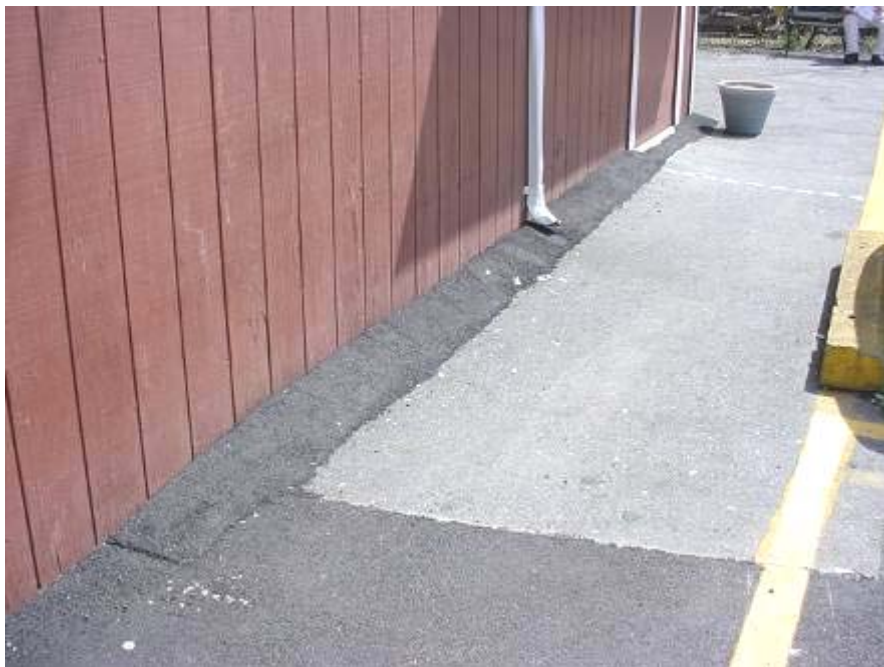
**Picture 6**

**Asphalt Berm against Exterior Wall**

14. Continue to examine methods to improve drainage around the building to prevent water pooling/infiltration. Consider contacting a building engineer or professional drainage/landscaping firm to examine other potential remediation/prevention strategies.

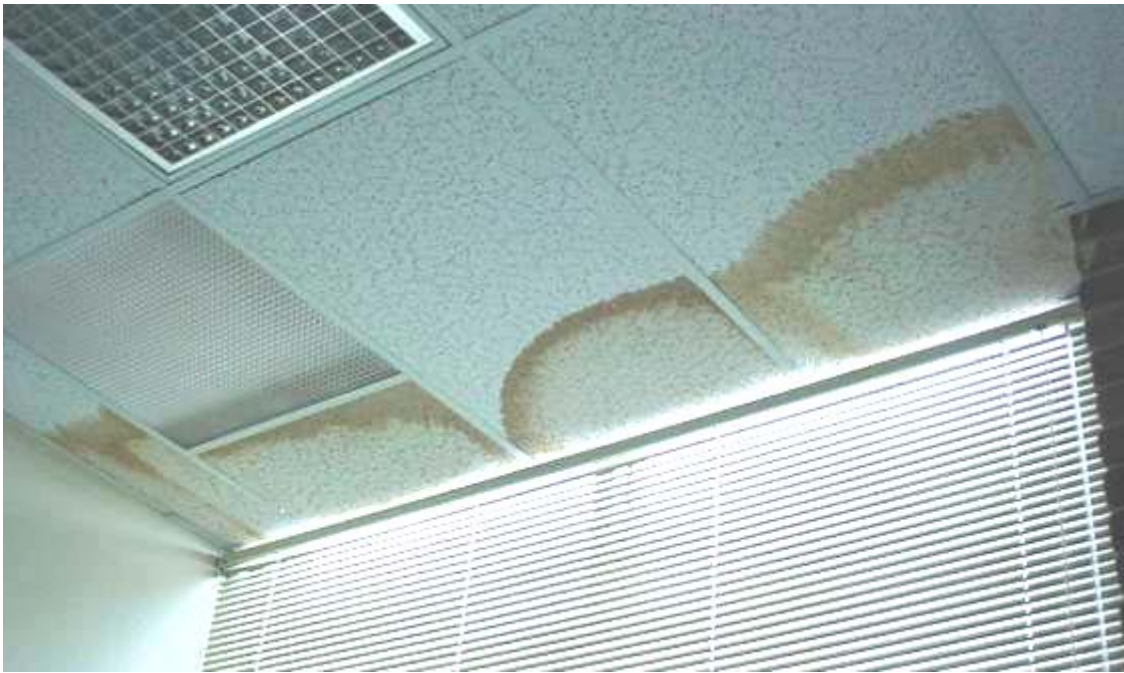
**Picture 7**

**Water Damaged Ceiling Tiles along Exterior Wall/Window Frame 2<sup>nd</sup> Floor**

7. Continue to repair any water leaks as they may occur, and replace any remaining water damaged ceiling tiles. Examine the areas above and behind these areas for mold growth. Disinfect areas of water leaks with an appropriate antimicrobial.

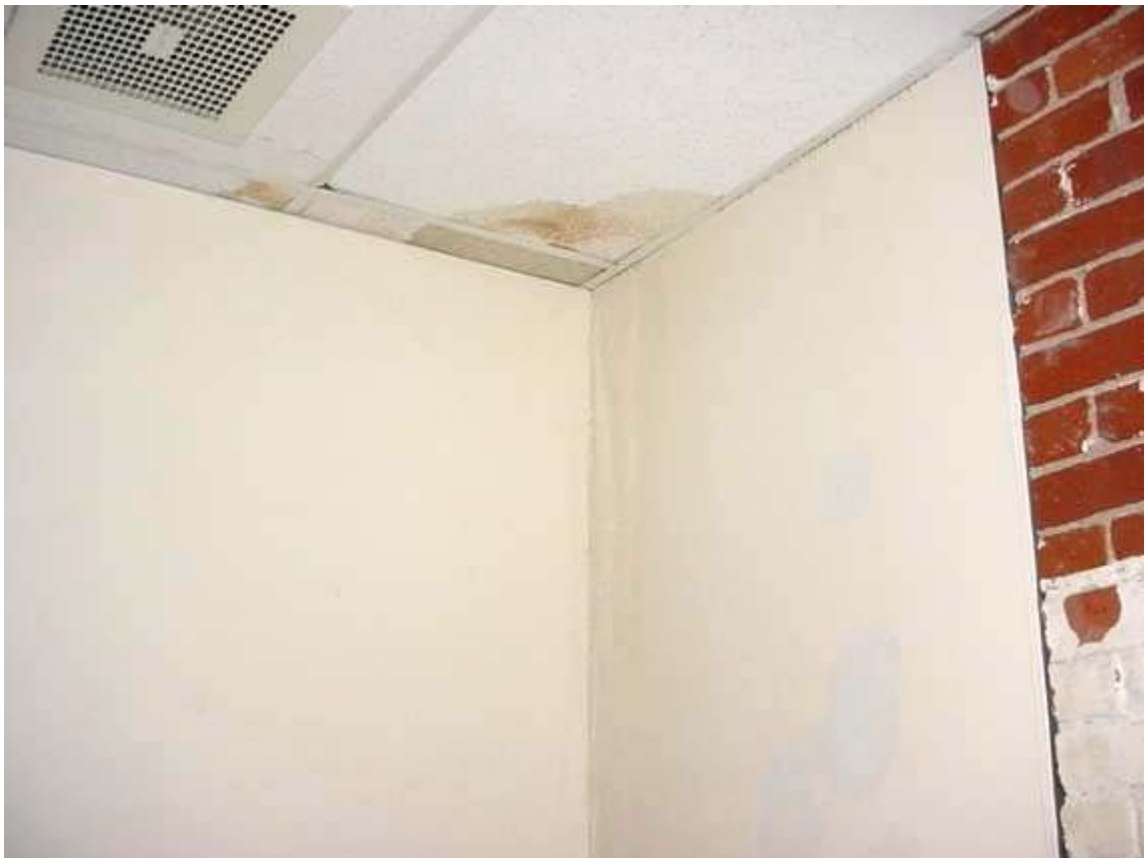
**Picture 8**

**Water Damaged Ceiling Tiles and GW in Kitchen/Break Room Area**

11. Make repairs/replace water damaged GW.
12. Ensure all plants are equipped with drip pans. Examine drip pans for mold growth and disinfect areas of water leaks with an appropriate antimicrobial where necessary.

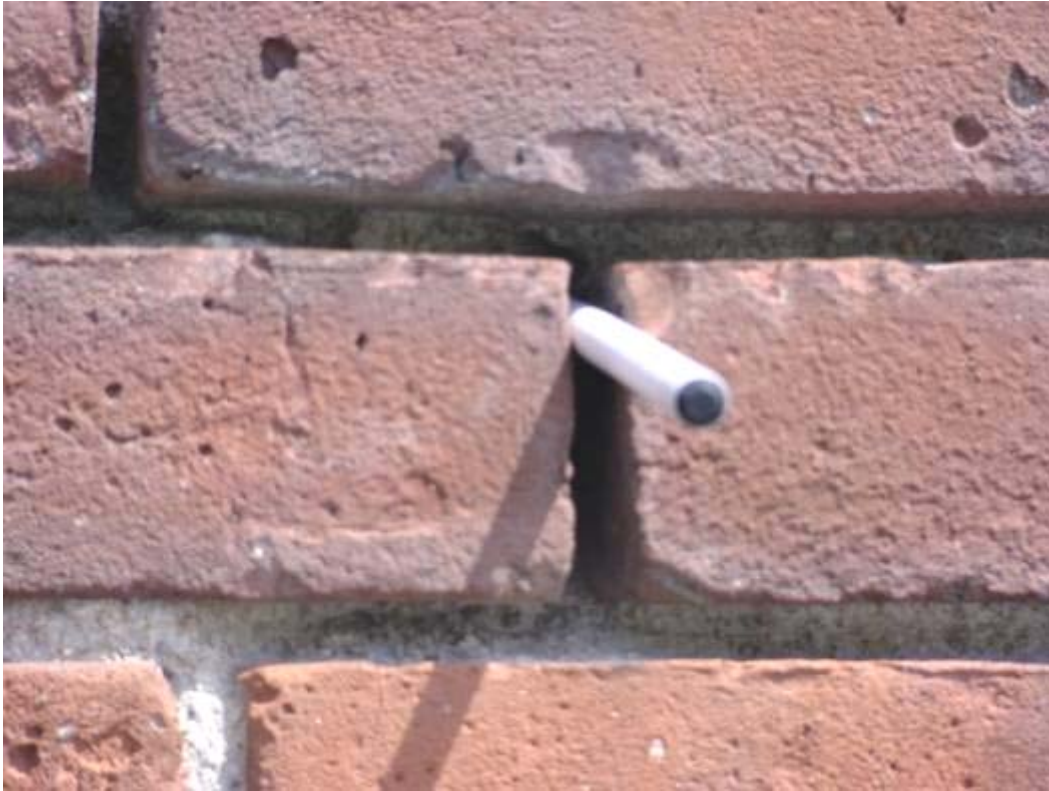
**Picture 9**

Missing/damaged mortar around the exterior of the building was observed in a number of areas, which can provide a source of water penetration (Pictures 9 and 10). A section of the roof eave was missing on the rear of the building (Pictures 11 and 12), which corresponded to water damaged areas on the interior of the DSS. Water staining down the side of the building and heavy moss growth was observed at the base of the exterior wall directly below this area indicating chronic wetting/water pooling.

**Missing/Damaged Mortar around Exterior Brick, Pen Inserted by BEH Staff to Show Depth**

9. Repair missing/damaged mortar in exterior walls to prevent water penetration, drafts and pest entry.
10. Continue with plans to remove water damaged carpeting. Consider installing a water-impermeable floor covering (e.g., tile) in areas susceptible to water penetration to prevent mold growth.

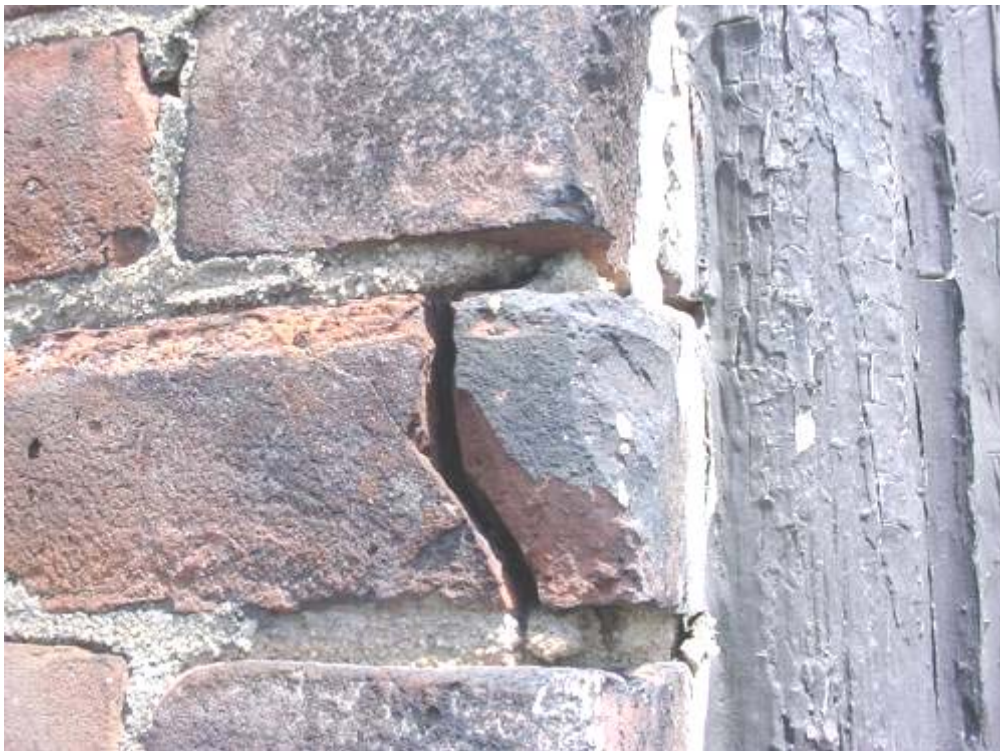
**Picture 10**

**Missing/Damaged Mortar/Damaged Exterior Brick**

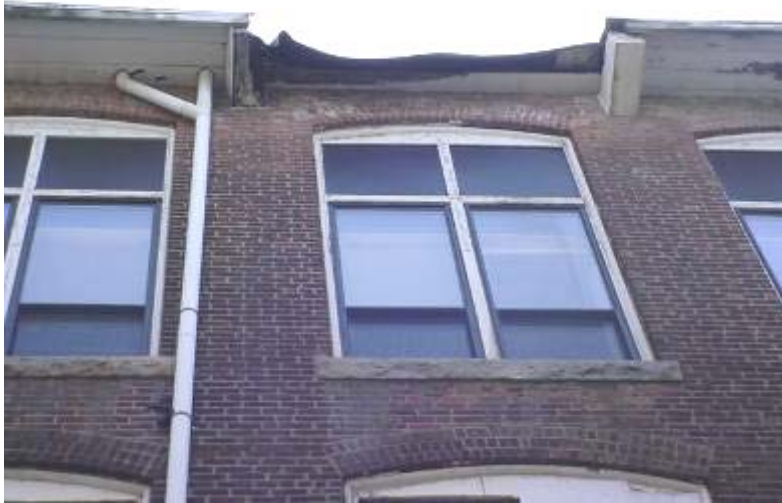
**Picture 11**

**Missing Section of Roof Eave at Rear of Building**

8. Make repairs/alterations to the damaged roof shown in Pictures 11 and 12 to provide drainage and to prevent water infiltration/pooling against the building.

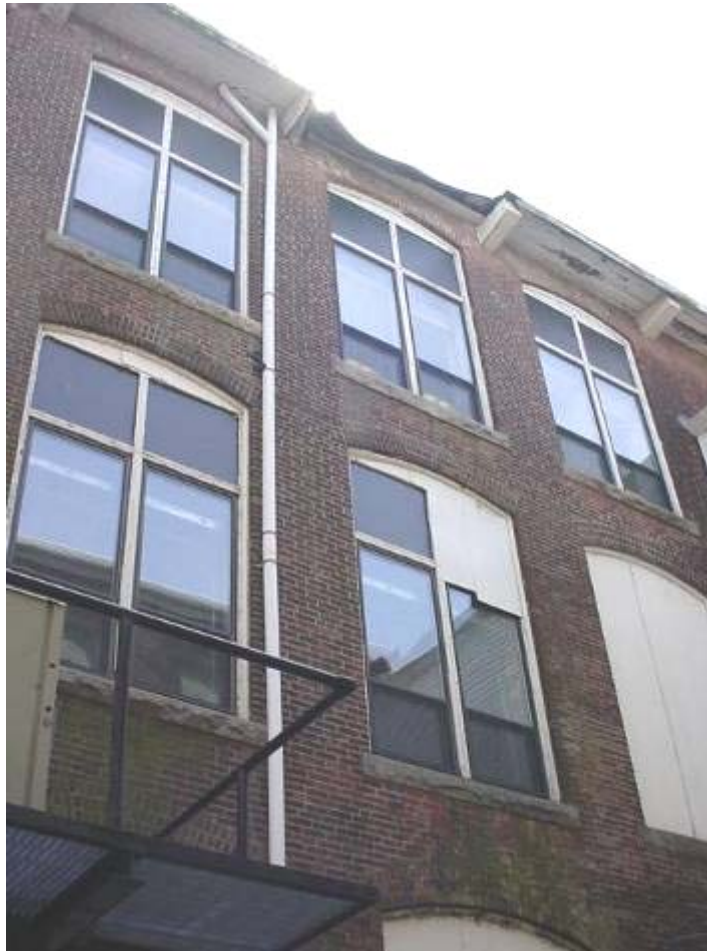
**Picture 12**

**Missing Section of Roof Eave at Rear of Building, Note Panels on Second Floor Window, Which may Provide a Pathway for Water Penetration**

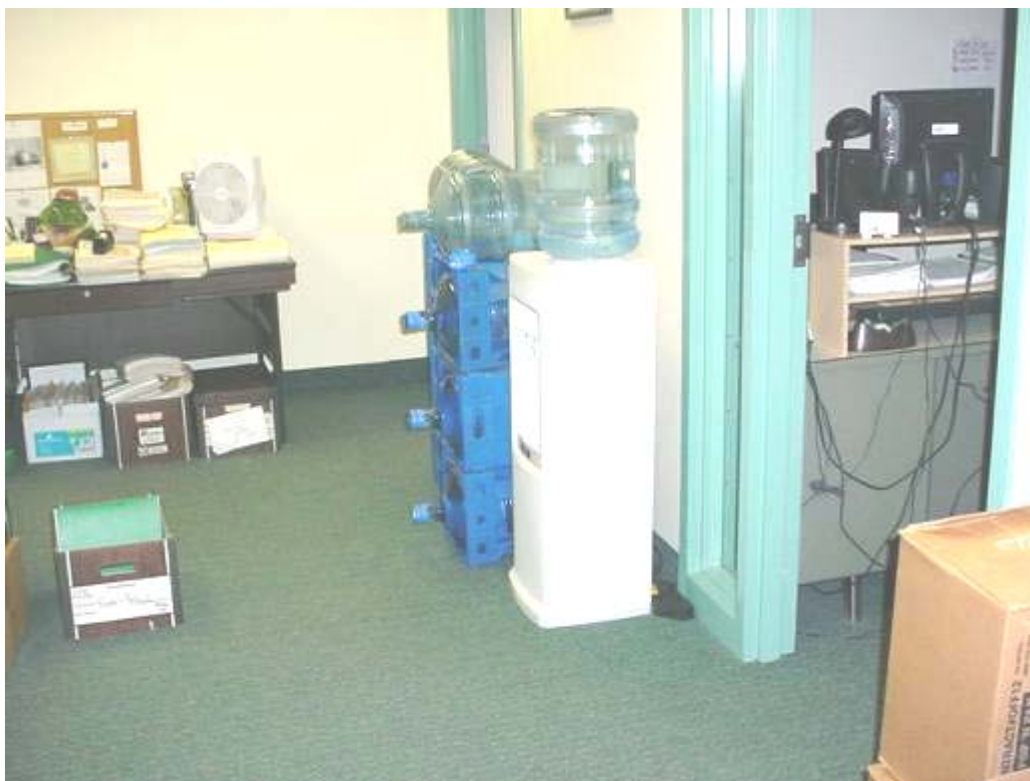
**Picture 13**

Water coolers were observed on carpeting (Picture 13). Water spillage or overflow of cooler catch basins can result in the wetting of the carpet. In addition, some of the coolers had residue/build-up in the reservoir. These reservoirs are designed to catch excess water during operation and should be emptied/cleaned regularly to prevent microbial and/or bacterial growth.

**Water Cooler and Containers on Carpeting**

13. Relocate or place tile or rubber matting underneath water coolers in carpeted areas. Clean and disinfect reservoirs as needed to prevent microbial growth.

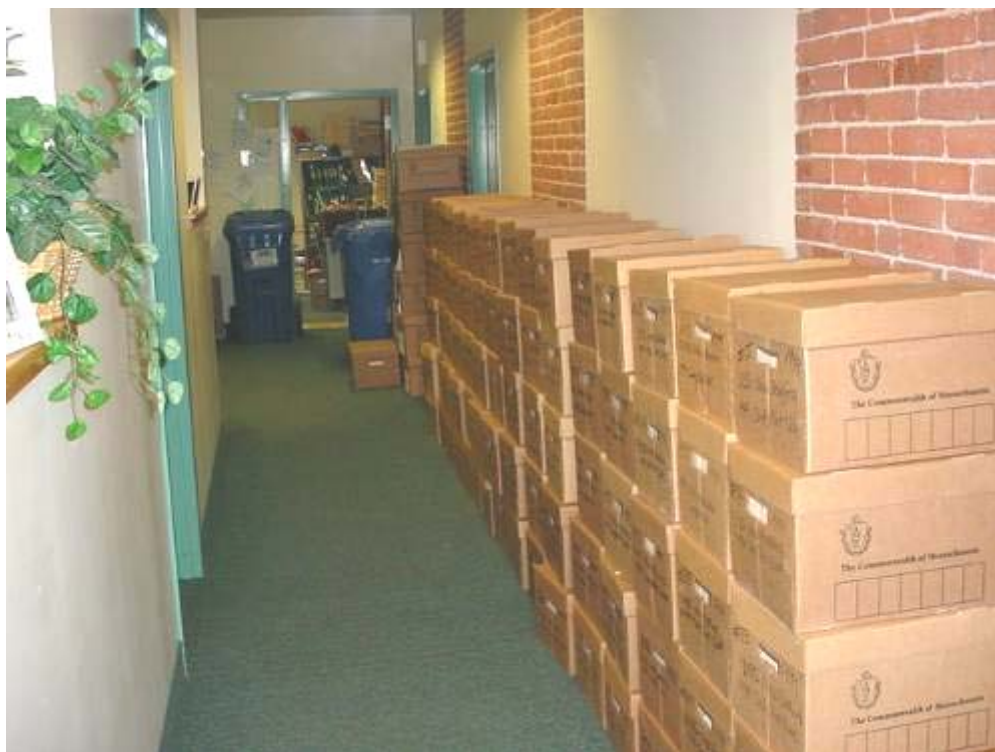
**Picture 14**

The amount of materials stored inside offices and common areas (Picture 14) should be noted. In areas throughout the building, items were observed on windowsills, tabletops, counters, bookcases and desks. The large number of items stored provides a source for dusts to accumulate. These items, (e.g., papers, folders, boxes) make it difficult for custodial staff to clean. Dust can be irritating to eyes, nose and respiratory tract. Items should be relocated and/or be cleaned periodically to avoid excessive dust build up.

**Boxes and Other Items Stored in Common Hallway**

15. Relocate or consider reducing the amount of materials stored in offices and common areas to allow for more thorough cleaning. Clean items regularly with a wet cloth or sponge to prevent excessive dust build-up.
